Bourne Police Headquarters Feasibility Study

Bourne, Massachusetts
September 30, 2016

KAESTLE BOOS
associates, inc

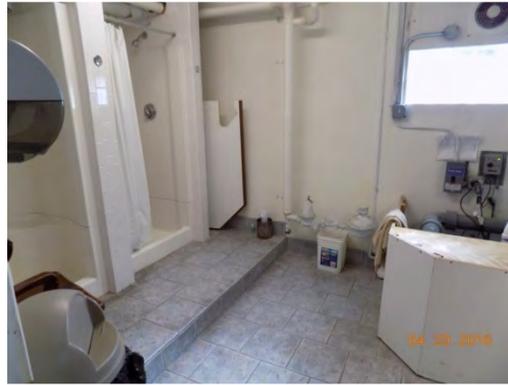
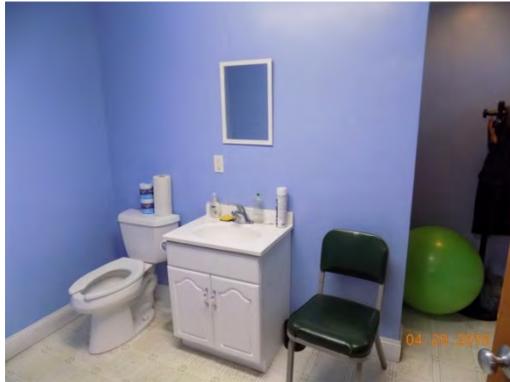
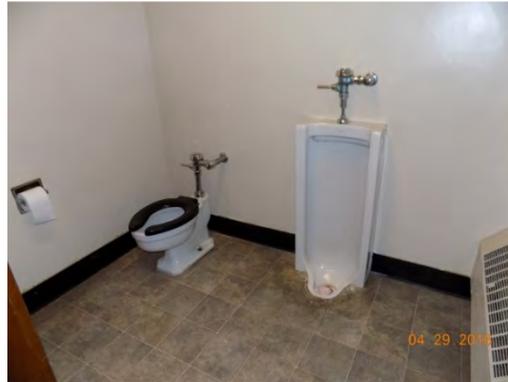
The toilet/shower rooms are painted walls, with tile flooring and acoustical tile ceiling. All finishes are old and need to be replaced.

The shower facilities are fiberglass enclosure type with a 3” lip at the base (non ADA/MAAB compliant). The enclosures appear to be in good condition. The shower stalls are also non ADA/MAAB compliant, as they are on a raised platform to allow the floor drains to drain into the sump pump.

Additionally, none of the fixtures meet ADA floor clearance requirements. The sinks do not have insulated drain piping or approved lever style faucets handles. The toilets do not have grab bars and or clearance from the wall. The showers do not have a flush lip at the floor, fold down seat or height adjustable shower head. Urinal is floor mounted and does not comply with current plumbing code. Additionally there are no separate toilet/shower facilities for male and female use.

Our recommendation would be to execute a total renovation of these spaces. All fixtures, partitions and accessories should be replaced with new.

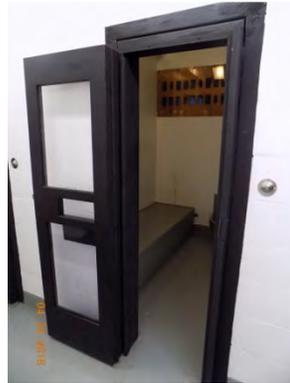
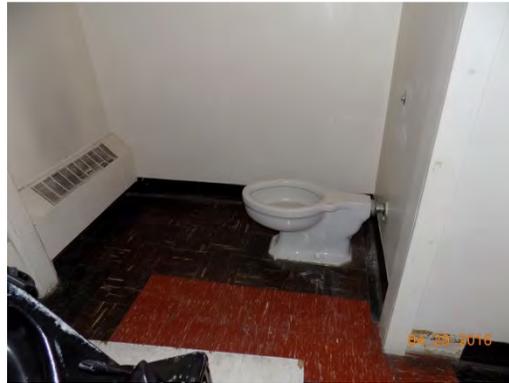
The cells do not meet any of the Massachusetts Department of Public Health requirements. The cell doors are too narrow, toilet fixtures are not detention grade, bunks are too small, finishes are failing and audio/video coverage is minimal at best. There are also many potential suicide risks; fin tube radiation covers, sink /toilet fixtures and faucets to name a few.

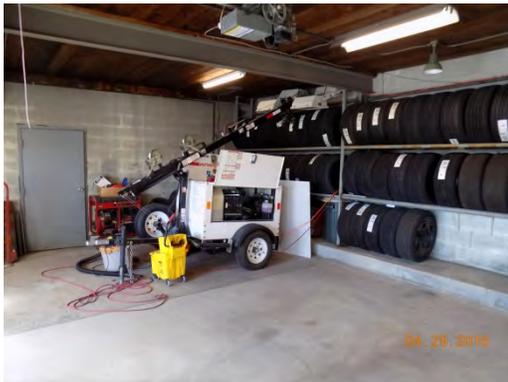
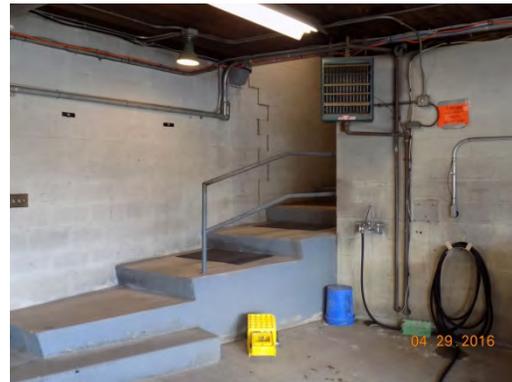
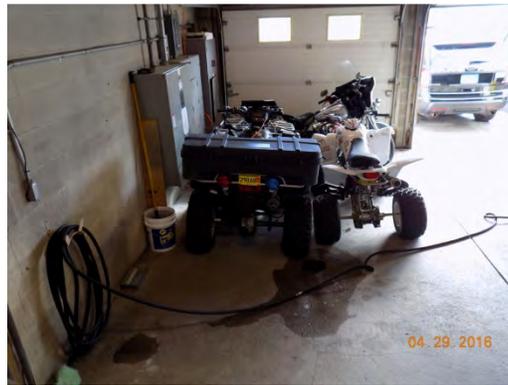
The Sally-port bays utilize painted cmu walls, painted exposed ceiling and exposed concrete floors. All of the finishes are in fair condition. The overhead door openings are too short as previously noted.

There is an open set of concrete steps that are a potential hazard to both officers and detainees. Additionally, because of the lack of storage within the station, the sally port is used for the storage of ATV's, tires, mobile sign board and misc. other materials, all of which are potential hazards to used against an officer.

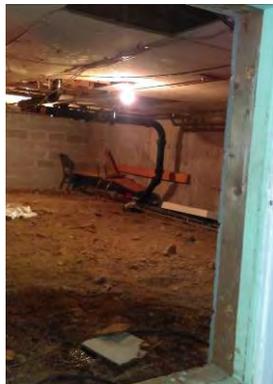
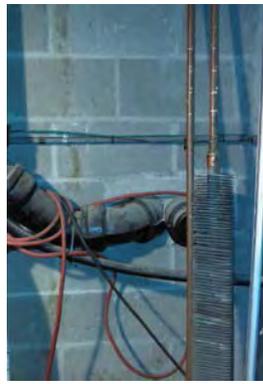
Cast Iron

Cast iron is used for sanitary and storm drainage. Where visible, the cast iron pipe appears to be in fair condition. Smaller pipe sizes appear to be copper. It was reported by the staff that there are partial blockages in the buried drains that cannot be cleared.

Existing buried sanitary, waste, vent and storm drainage piping should be videotaped by a Contractor to determine internal condition of piping and to check for leaks. Any buried drainage piping found to be leaking, compromised or in poor condition should be replaced.

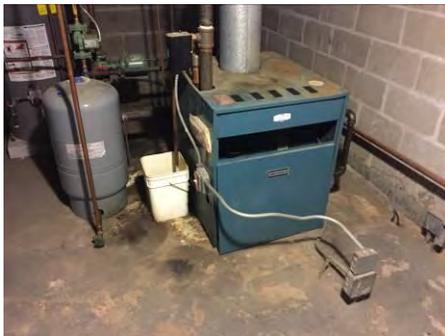
Hot Water Boiler

The Police Station is heated by a hot water boiler plant consisting of one (1) gas fired hot water boiler, hot water pumps, accessories, breeching, combustion air opening and standalone controls. The boiler is a Burnham fire tube boiler, which was replaced approximately ten to twelve years ago. The boiler has an input heating capacity of 396 MBH and utilizes natural gas as its main fuel source. Originally, the boiler plant operated on fuel oil and was associated with an underground fuel oil tank; the tank has since been removed along with the fuel oil piping, however, there is an original fuel level gauge still present within the boiler room. The boiler appears to have all the necessary safeties. The boiler appeared to be in fair condition and functioning properly, however, there are signs of corrosion on the boiler casing.

- **Heating System:** The existing hot water boiler is inefficient in comparison to today's energy efficient boilers. We recommend that the existing boiler is replaced with a high efficiency condensing hot water boiler plant, consisting of high efficiency condensing boiler, pumps equipped with VFD drives (or ECM motors), DDC controls (including outdoor air reset), and accessories. A new steel/copper main header piping distribution system should be provided to replace the existing hot water piping located throughout the building, as well as, new hot water fintube radiation elements for each space with individual temperature controls.

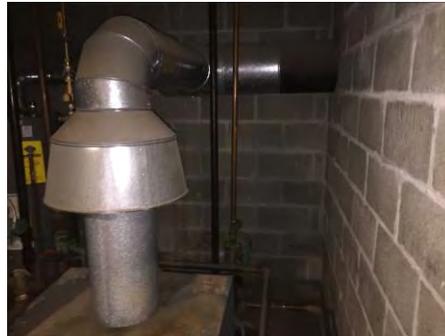
Breeching System

The boiler flue gases are vented through the use of a single wall galvanized breeching system, which terminates into an existing masonry chimney. Combustion air for the boiler appears to be provided through one louvered opening which communicate directly with the outside. The current size of the opening does meet today's combustions air requirements.

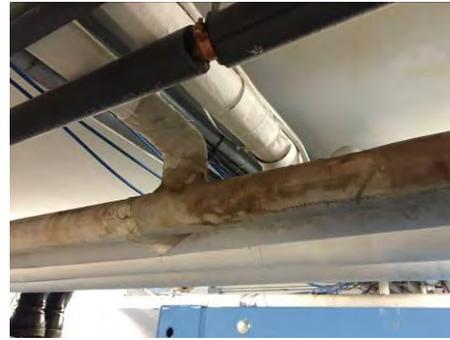
Piping within the boiler room and throughout the building is a combination of schedule 40 black steel and copper. From an outwards appearance, the piping is in fair condition, however, sample sections of piping should be cut and examined to determine the actual interior condition of the piping system. All of the piping within the boiler room was not insulated, however throughout the building some sections of piping did appear to have the original fiberglass insulation with asbestos elbows. Further testing or verification should be considered to quantify what is asbestos and what is not. The hot water piping that was insulated appears to be in poor condition with slight damage to some sections and even soiled in others, there was quite a bit of piping that was missing insulation which does not meet today's codes and standards. The distribution piping system is a two-pipe system with hydronic control valves at certain sections of the fin tube radiation.

Soiled Piping Insulation

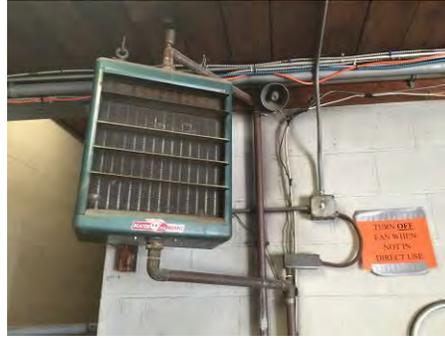
Sallyport Unit Heater

The Sallyport area is not provided with any Vehicle Exhaust System nor is it provided with an exhaust fan to vent vehicle exhaust upon entry and exit. There is one vertical propeller style unit heater within the space which does not function properly. It was also noted to have extensive surface soiling and contamination and this heater does not have the adequate capacity to heat the garage.

- Restroom exhaust air fan systems should be replaced including associated ductwork and roof mounted exhaust fan.
- Heating and ventilation systems should be provided for the Sallyport including CO/NO2 sensors and alarms.

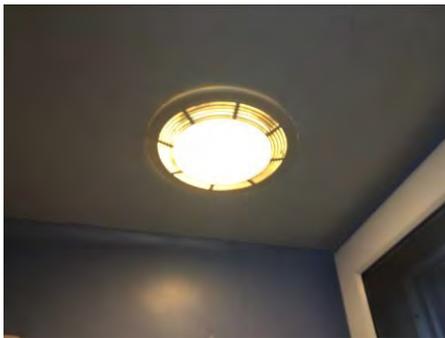
Restroom Exhaust Fan

All of the restrooms throughout the building utilize wall mounted fin tube radiation as a main heat source. There is no thermostat to control space heating in any of the restrooms. Only some restrooms are equipped with exhaust fan systems, this condition should be improved upon as this does not meet today's codes and standards for restroom ventilation requirements.

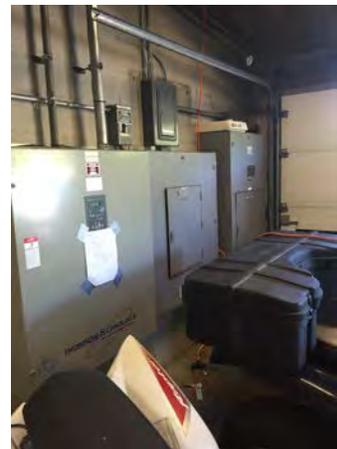
Electrical Distribution Equipment

The electrical distribution equipment is manufactured by Federal Pacific and is of circuit breaker type. The equipment is in poor condition.

The original building switchgear should be replaced. New panelboards should be provided and existing circuits reconnected.

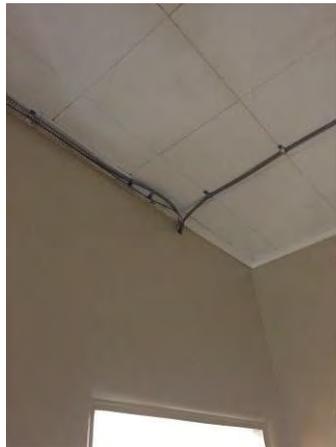
Exposed MC Cable

In general, the condition of the branch circuits and receptacles is poor. Receptacle coverage is inadequate and extension cords were noted. The use of extension cords to replace permanent wiring is a code violation. MC cable is used in exposed areas subject to physical damage. Extension cords are being used as branch circuits which is a code violation.

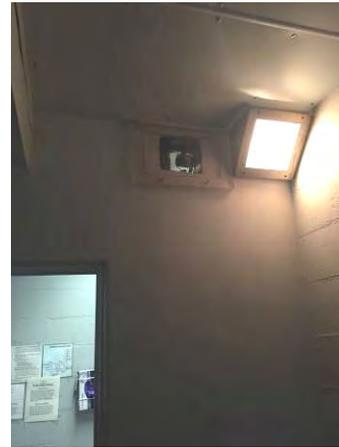
Cell Light

Cells have corner mounted security fixtures with incandescent lamps. One switch with pilot light for each cell light is located in the hallway. Cell lights provide inadequate lighting to monitor detainees.

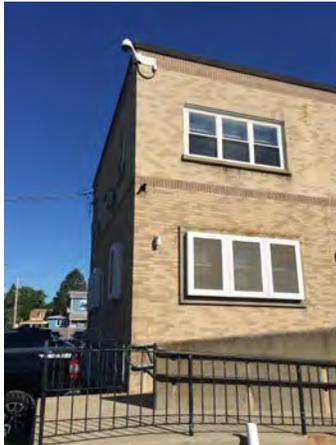
Building Mounted Lighting

The exterior lighting is inadequate and is not dark sky compliant.
