Bourne Police Headquarters Feasibility Study

Bourne, Massachusetts
September 30, 2016

KAESTLE BOOS
associates, inc

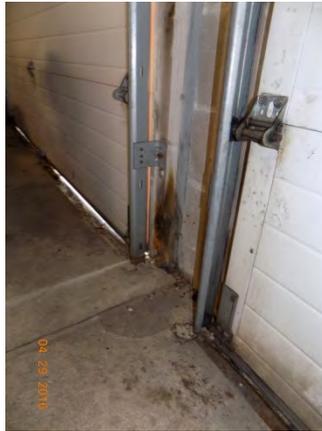
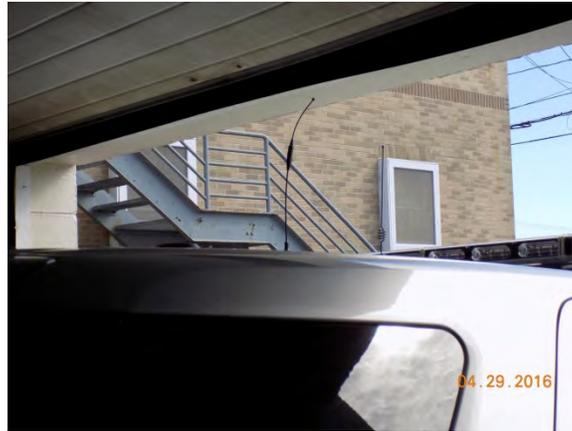
The entrance door and frame is anodized aluminum with glass vision panels. Doors and frames are generally in poor condition. The hardware, seals and caulking all appear to be in failing condition. None of the doors have been outfitted with a “crash-bars”; though most of the doors are equipped with lever handles.

The sally port doors are prefinished insulated metal sectional overhead type with one row of vision panels. Weather gaskets at the door bottom and jambs are failing. The doors are showing wear and appear to be at or near their expected live span. Additionally, the door openings themselves are too short for the current SUV type cruisers (antennas hit the door head damaging the antennas).

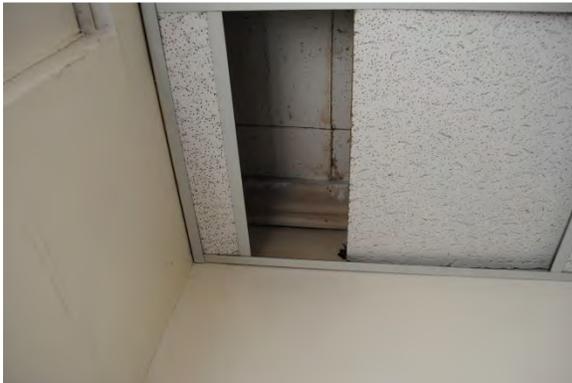
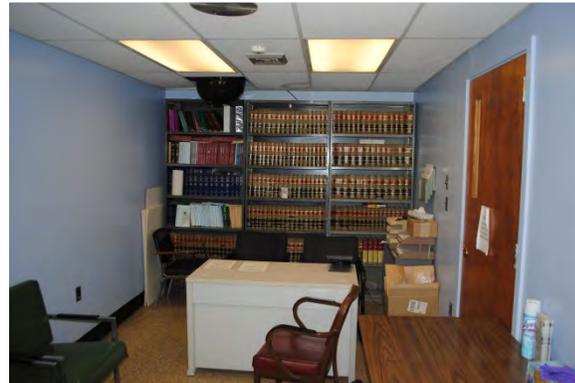
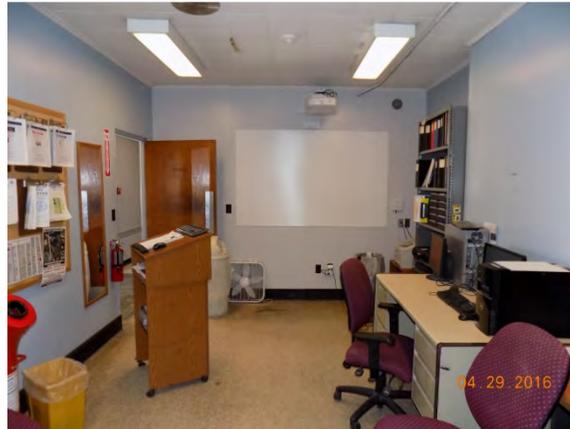
There are three predominant ceiling types in the building: painted gypsum wall board (lobby, mechanical, and detention areas), 12"x12" acoustical ceiling tile on furring channels (mainly in original building areas), and 24"x24" acoustical ceiling panels in prefinished aluminum suspension framing system. It was observed in a number of locations above the suspended ceiling, the original 12"x12" ceiling tiles remains and exhibit wide spread water staining. It is not apparent if this is due to past roof leaks that have been repaired or current leaks that have not stained the suspended ceiling tiles. Further investigation is required.

In general, the gypsum board ceilings could use minor repairs and a fresh coat of paint, while the suspended ceiling system is in good condition. Stained ceiling tiles need to be replaced once the source of the water infiltration has been fixed.

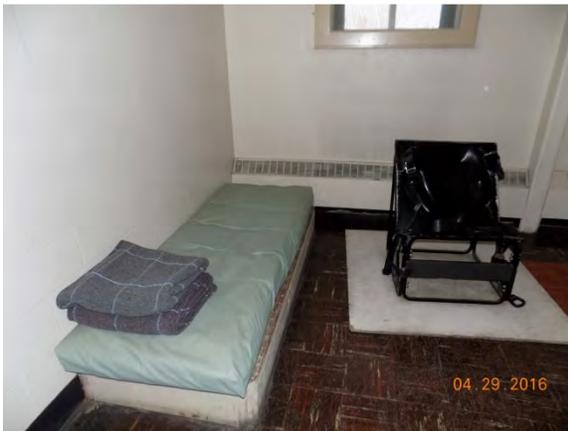
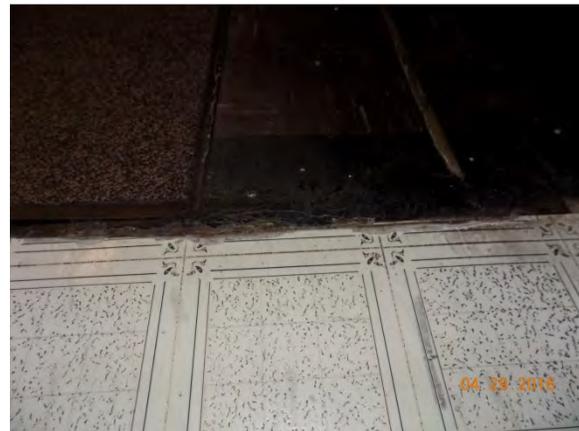
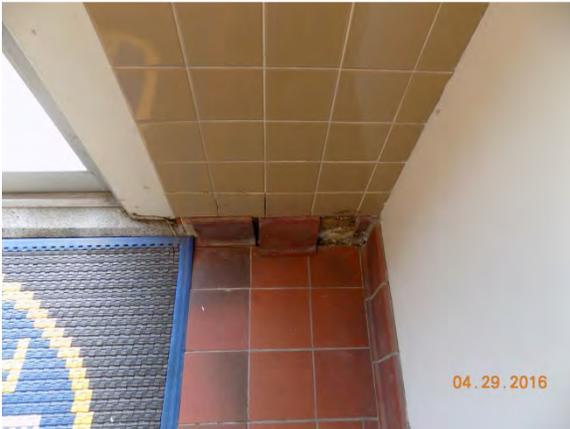
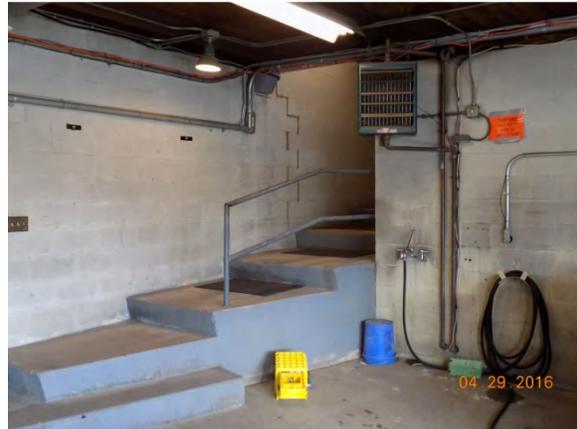
There are numerous flooring materials used throughout building: vinyl composite tile (VCT), ceramic tile, sheet vinyl, vinyl asbestos tile (suspected), carpet, painted and exposed concrete. In general, all are in poor condition and needs be replaced.

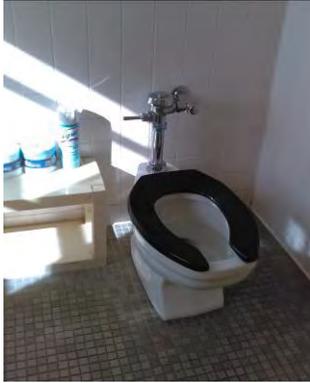
Typical Water Closet

Urinals are wall hung or pedestal vitreous china with manually operated flush valves.

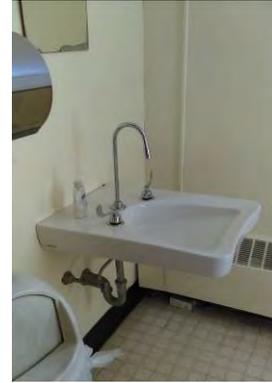
Typical Lavatory

Lavatories are wall hung or counter mounted made of vitreous china. The majority of lavatories have been retrofitted with single handle mixing faucets. Some lavatories are fitted with hot and cold water handle faucets.

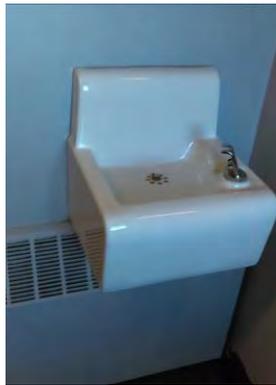
Drinking Fountain

Drinking fountains consist of vitreous china fountains.

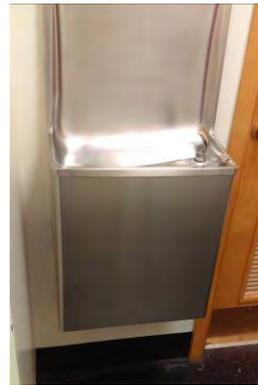
Water Cooler

Electric water coolers are wall hung, non accessible.

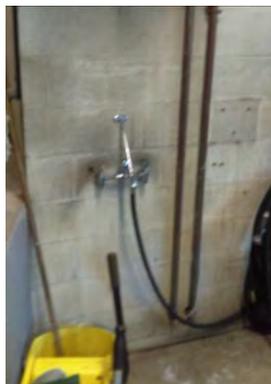
Sallyport Faucet

Janitor's sinks are generally trap standard mounted, enameled cast iron sinks. Faucets are equipped with vacuum breakers. The Sallyport includes a wall mounted faucet with threaded connection and vacuum breaker without a floor receptor.

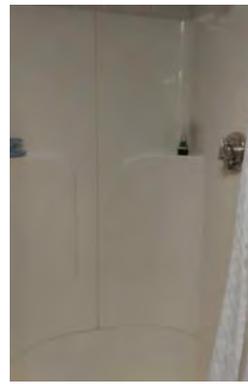
Shower

Showers are made of a non-accessible fiberglass surround and include a thermostatic mixing valve and standard flow shower head.

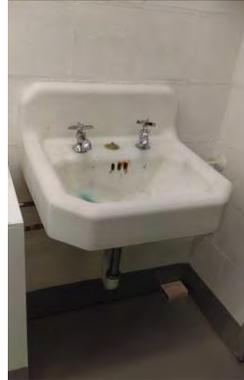
Cell Lavatory

In each cell, either a stainless steel or vitreous china water closet is provided with a wall mounted flush valve pushbutton. Handwashing is done outside of the cells with a wall mounted vitreous china lavatory with hot and cold water faucets.

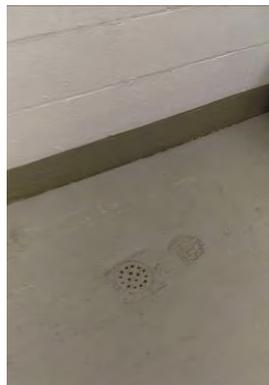
Garage Drain

The Sallyport does include garage drains. It was indicated that the garage drains are not directed to a Code required exterior gasoline/oil interceptor.

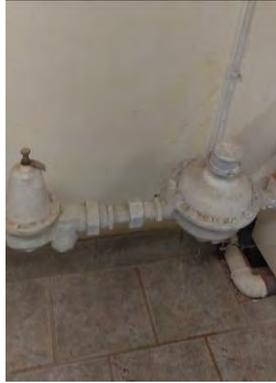
Water Meter

The main domestic water service is located in the Basement. The service is 1-1/2" in size and includes a 1-1/4" water meter and pressure reducing valve. The main domestic cold-water distribution is 1-1/2" in size. The majority of the domestic distribution piping is located at or above ceilings throughout the facility.

The domestic water is aggressive leading to corrosion and early failure of piping, fittings, and valves.

Domestic water piping should be replaced including fittings, valves, insulation. Valves should be tagged and piping labeled per ANSI Standards.

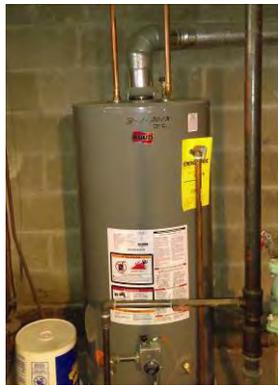
Gas-fired Water Heater

Domestic hot water in the building is generated through a gas fired storage tank type water heater. The hot water system is recirculated. There is no thermostatic mixing valves on the systems to prevent scalding and there is no expansion tank on the cold water make-up line to the water heater.

The water heater has a natural gas input of 40,000 BTUH and a 50-gallon storage capacity. The water heater appears to be in good condition.

Domestic water heater should be replaced with a high efficiency, gas fired, storage type water heater and include an expansion tank, thermostatic mixing valve and a hot water recirculation pump.

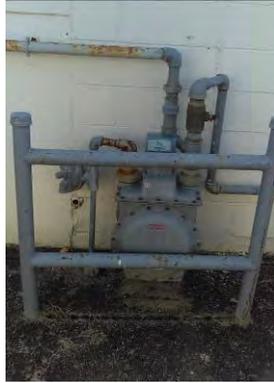
Gas Meter

A 3/4" elevated pressure natural gas service is supplied to the building. An exterior gas meter and regulator is located on the side of the Sallyport / Garage. Natural gas is distributed throughout exposed on the exterior wall, and through building from this location. Natural Gas is utilized for domestic water heating, building heating and the gas fired emergency generator.

Paint all exposed gas piping on roof or at meter location with rust inhibitive paint.

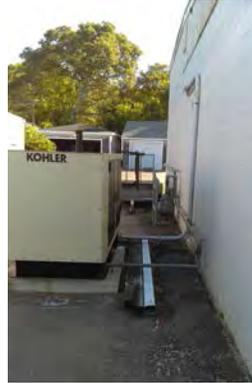
Gas Generator

Gas piping is black steel with a combination of screwed and welded joints and fittings depending on the time or pipe size of the installation.

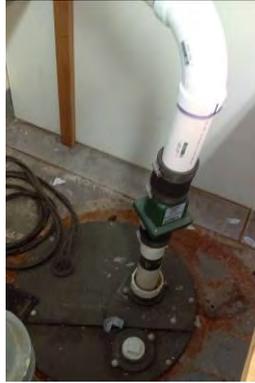
Sump Pump

There is a storm sump pump in basin in the Basement, used for groundwater infiltration prevention.

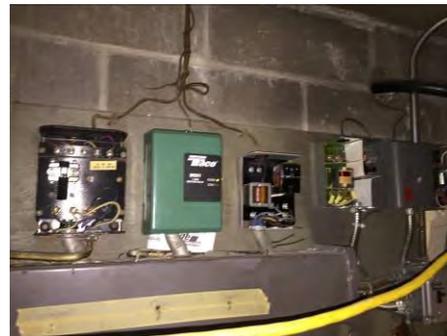
Boiler Controls

The Police Station is heated by a hot water boiler plant consisting of one (1) gas fired hot water boiler, hot water pumps, accessories, breeching, combustion air opening and standalone controls. The boiler is a Burnham fire tube boiler, which was replaced approximately ten to twelve years ago. The boiler has an input heating capacity of 396 MBH and utilizes natural gas as its main fuel source. Originally, the boiler plant operated on fuel oil and was associated with an underground fuel oil tank; the tank has since been removed along with the fuel oil piping, however, there is an original fuel level gauge still present within the boiler room. The boiler appears to have all the necessary safeties. The boiler appeared to be in fair condition and functioning properly, however, there are signs of corrosion on the boiler casing.

- **Heating System:** The existing hot water boiler is inefficient in comparison to today's energy efficient boilers. We recommend that the existing boiler is replaced with a high efficiency condensing hot water boiler plant, consisting of high efficiency condensing boiler, pumps equipped with VFD drives (or ECM motors), DDC controls (including outdoor air reset), and accessories. A new steel/copper main header piping distribution system should be provided to replace the existing hot water piping located throughout the building, as well as, new hot water fintube radiation elements for each space with individual temperature controls.

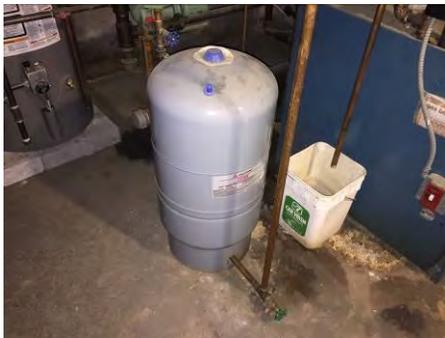
Expansion Tank

Hot water is distributed from the boilers to the building heating equipment by several inline circulators. There is a total of six Taco inline pumps which serve dedicated areas such as the first floor, second floor, cell block, garage, etc. The pump motors are equipped with typical starters and do not have any variable speed drives associated with them. These pumps appear to have been installed at the same time as the boiler, overall the pumps appeared to be in good condition. Associated with the hot water system is one non-insulated expansion tank and one non-insulated air scoop; there was no sign of a chemical shot feeder.

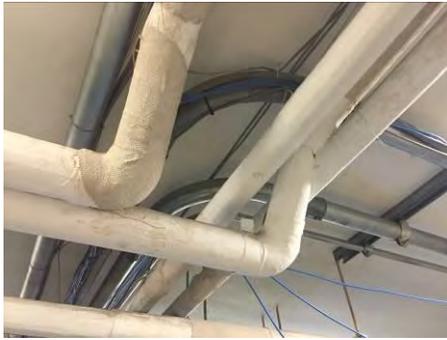
Typical Piping

Piping within the boiler room and throughout the building is a combination of schedule 40 black steel and copper. From an outwards appearance, the piping is in fair condition, however, sample sections of piping should be cut and examined to determine the actual interior condition of the piping system. All of the piping within the boiler room was not insulated, however throughout the building some sections of piping did appear to have the original fiberglass insulation with asbestos elbows. Further testing or verification should be considered to quantify what is asbestos and what is not. The hot water piping that was insulated appears to be in poor condition with slight damage to some sections and even soiled in others, there was quite a bit of piping that was missing insulation which does not meet today's codes and standards. The distribution piping system is a two-pipe system with hydronic control valves at certain sections of the fin tube radiation.

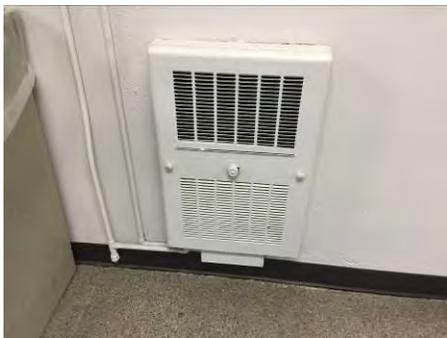
Locker Room Convector

The Men’s locker room and the evidence storage room are located in the basement of the building. These spaces utilize convectors/unit heaters for heating purposes. There are no exhaust fans associated with the locker room which does not allow for any ventilation air, which in turn provides poor indoor air quality. In a space such as the locker rooms, some type of ventilation / exhaust system should be considered to reduce odors in the air and minimize pollutants. The evidence storage room did have a ceiling exhaust fan which seemed to be original to the building, this fan was not operating. This condition should be improved upon as there are substances within the space which create strong odors.

- Ventilation: We recommend that a new ventilation system with insulated galvanized sheetmetal ductwork be provided to ensure odors and pollutants are minimized and/or eliminated. New mechanical ventilation systems should be provided for all areas of the building.

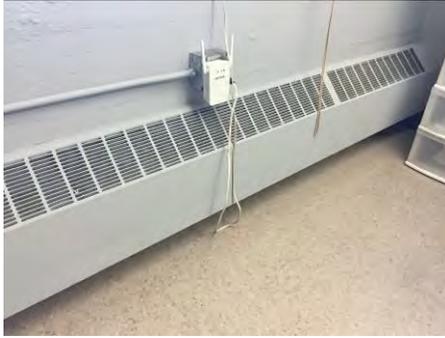
Second Floor Fin Tube

All of the spaces on this floor consisted of wall mounted fin tube radiation as its main heat source, except for the sally port, which had no fin tube radiation and utilized one vertical propeller unit heater. The fin tube radiation was mainly located on the exterior walls and for the most part were in fair condition, some section of cover was damaged; covers missing and fins bent or filled with debris. This condition minimizes the overall heating output of the fin tube and ultimately requires the boiler plant to operate more often and therefore less efficient. There appeared to be a handful of thermostats which controlled hot water flow through long sections of fin tube. The location of these thermostats were not necessarily placed in the best locations and did not provide the best temperature readings for the spaces in which it controlled. For example, there is one thermostat in the dispatch area which controls the heating for several different rooms, which have different exposures and different lengths of exterior walls. This current condition provides uneven temperatures and provides under and overheating in the spaces. To correct this condition, the piping system would have to be modified to allow separate hot water feeds to each space, which would then allow individual thermostats for each space. This would provide individual occupant control. Some of the spaces were also provided with window air conditioners which were functioning.

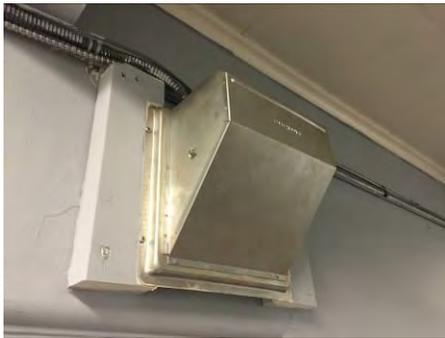
Typical Interior Exhaust Fan

The Cell block area is provided with individual exhaust fans which are associated with a perforated wall area in each cell block. The fans are wall mounted and discharge into the plumbing chase behind the cell blocks and do not exit the building. This condition does not provide adequate ventilation for the cells and this condition should be improved upon. There is no makeup air provided to the individual cells, and with the security doors installed, adequate makeup air is not allowed to enter the cells when the cells are occupied. Makeup air for the entire cellblock is through the use of operable windows in an adjacent corridor and does not need the natural ventilation requirement of the building code. Heating for the cell blocks are provided by wall mounted fin tube radiation, however, the fin tube is located within the pipe chase which is between the cell block wall and the exterior building wall. Heat is transferred to the cells through a perforated section of wall located high within the cells. This condition does not provide adequate heating for the cells but does temper the area in which the cell blocks reside.

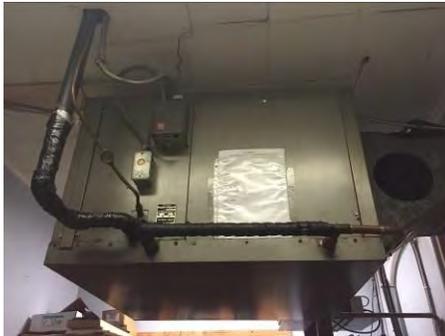
Indoor Air Handling

The radio room is centrally located within the first floor and houses all of the IT equipment racks and radio components. This space has a ceiling suspended indoor air handling unit which is utilized for cooling the dispatch area, the interview room, and the main lobby. The unit is associated with a galvanized supply duct distribution system which travels to each space indicated above and terminates at the ceiling with a supply grille. The unit is original to the building and is manufactured by Whirlpool and has a capacity of four tons of cooling. The unit is not insulated therefore a condensate pan has been installed under the unit. However, during the summer months the pan and the unit's base will form condensation and begin to drip onto the floor which has caused issues with the floor below, as well as, issues with the equipment within the space. The ductwork associated with this unit is exposed within this space and is not insulated. Recently the radio room itself required cooling due to the amount of equipment within the space, therefore, holes were cut into the supply ductwork to allow cool air to enter the radio room. This modification has decreased the cooling capability of the unit for the associated spaces. It is recommended that a separate split cooling unit be provided just for the radio room.

- Air Conditioning: We recommend that a new high efficiency air conditioning system(s) be installed in areas that require air conditioning to replace the existing air handling unit and associated condensing unit installed in the building. The replacement system should utilize alternative refrigerant to replace the existing R-22 refrigerant AC system. A new system would be recommended for the building that could meet the cooling load requirements of the building and improve overall thermal comfort and energy efficiency.

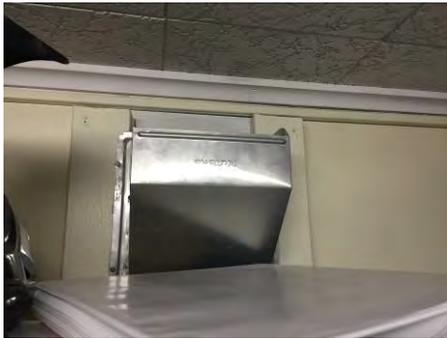
Typical Single Exhaust Fan

The Women's locker room is also provided with wall mounted fin tube radiation for heating. This space does not have any temperature control and depends on the adjacent space thermostat to control its space temperature. It does have a single wall mounted exhaust fan, however, it exhausts the air into the adjacent cell which does not meet today's codes and standards.

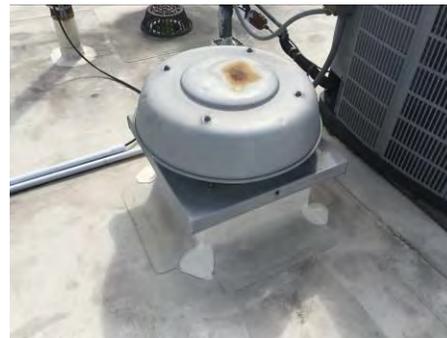
Roof Exhaust Fan

All of the restrooms throughout the building utilize wall mounted fin tube radiation as a main heat source. There is no thermostat to control space heating in any of the restrooms. Only some restrooms are equipped with exhaust fan systems, this condition should be improved upon as this does not meet today's codes and standards for restroom ventilation requirements.

- Restroom exhaust air fan systems should be replaced including associated ductwork and roof mounted exhaust fan.
- Heating and ventilation systems should be provided for the Sallyport including CO/NO2 sensors and alarms.

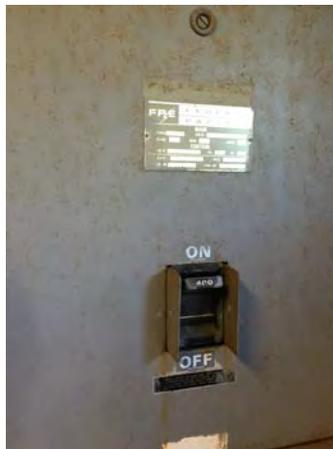
Main 400 Amp Service Breaker

The primary service runs overhead to a pole adjacent to the building on Harrison Avenue. The transformers are utility owned and pole mounted. The Utility Company is Eversource. Secondary service runs underground between the pole mounted transformers and a 400 Ampere, 120/208 Volt, 3 Phase, 4 Wire main circuit breaker via a C.T. cabinet. The C.T. cabinet had no utility company locks and could be accessed; the meter is located outside of the sally port, meter #5090653. The main service equipment is located within the sally port, and was blocked by police vehicles/ATV's.

The electrical distribution equipment is manufactured by Federal Pacific and is of circuit breaker type. The equipment is in poor condition.

The existing electric service should be replaced with a new 800 Ampere service.

The original building switchgear should be replaced. New panelboards should be provided and existing circuits reconnected.

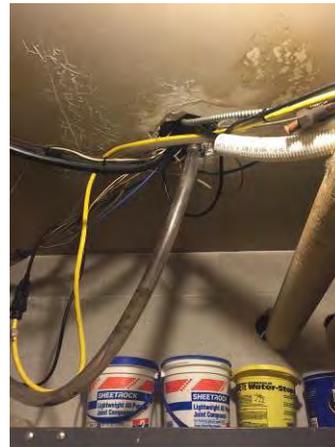
Extension Cords as Branch Circuits

In general, the condition of the branch circuits and receptacles is poor. Receptacle coverage is inadequate and extension cords were noted. The use of extension cords to replace permanent wiring is a code violation. MC cable is used in exposed areas subject to physical damage. Extension cords are being used as branch circuits which is a code violation.

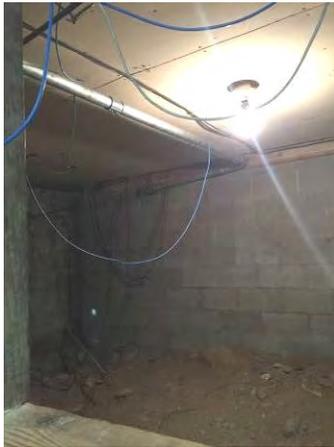
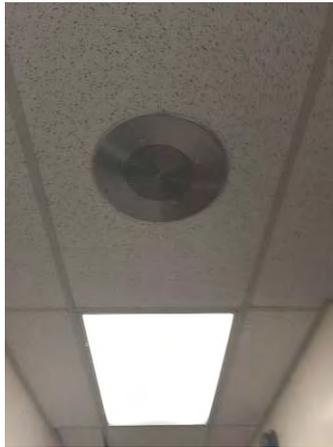
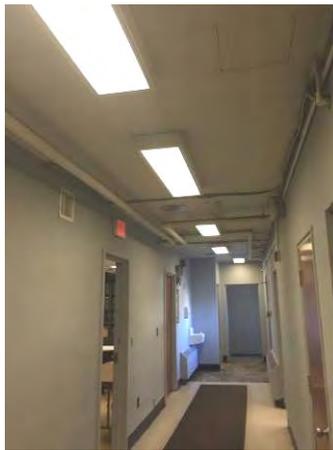
General interior lighting is in poor condition.

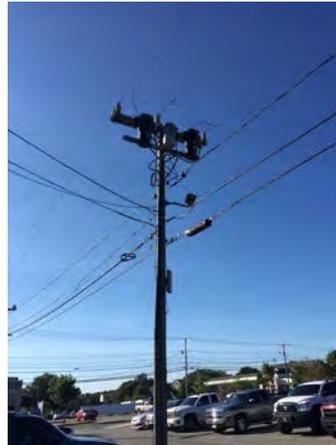
Flood Light on Utility Pole

The exterior lighting is inadequate and is not dark sky compliant.

Exterior wall sconces should be replaced with LED sconces. Pole-mounted LED fixtures should be provided for parking areas. All fixtures should be dark sky compliant.

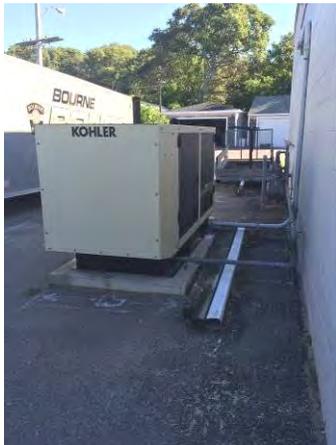
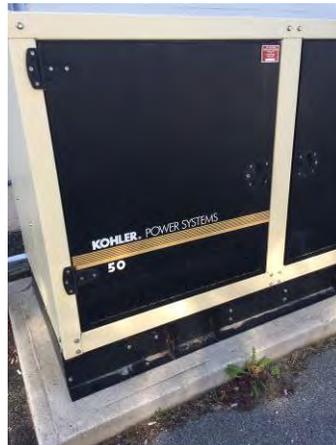
Generator

A 50 KW Kohler generator was recently installed. The generator was located exterior and is natural gas fired. The transfer switch is located inside the sally port. The generator is in fair condition, however, would not be adequate in size for any substantial renovation or new building project.

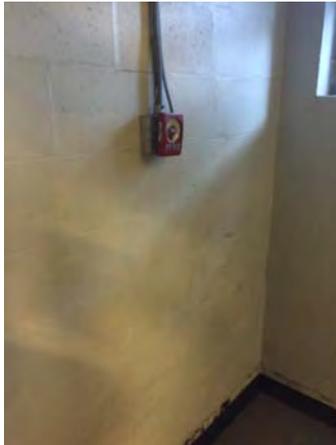
Pull Station

The existing fire alarm system is not currently operational; it is a conventional 4 zone ESL panel. The station contains smokes only devices, based on input from the Owner during the walk-thru. The current fire alarm system does not meet code and requires upgrades. Pull stations are not ADA compliant.

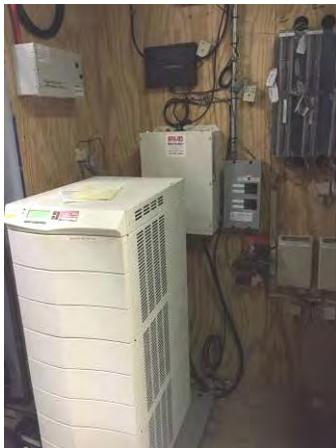
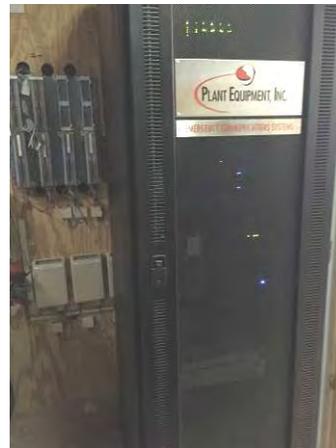
E911 emergency communications equipment and UPS is located in the building’s Data Room.

Dispatch has two positions. The emergency communications equipment rack, E-911, UPS and associated distribution equipment is required to be housed in a dedicated fire rated room.

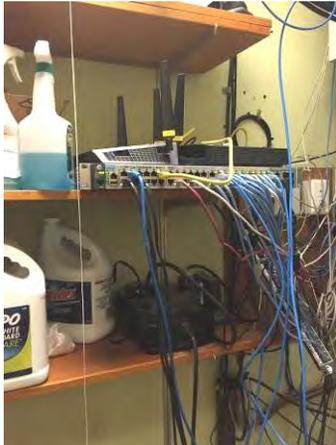
Building Data

The CAT5 cabling is generally exposed and improperly supported from other trades piping.

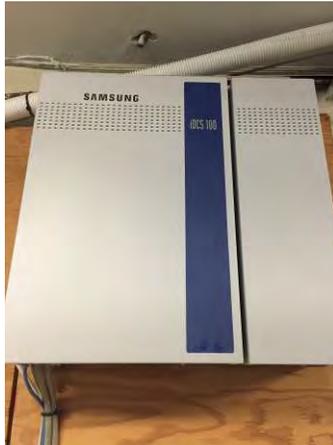
Telephone Head End

The Samsung iDCS 100 phone system has been problematic causing unnecessary downtime for the Police Department.
